Manhole Inspection Summary

Manhole # S37YY_020MH

Insp Date: **12/29/06 10:21 AM**

Location Address: **400 33RD ST**

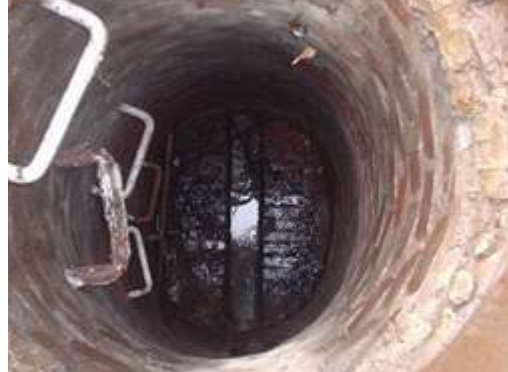
Top View

Corroded steps. Bench and Channel debris.

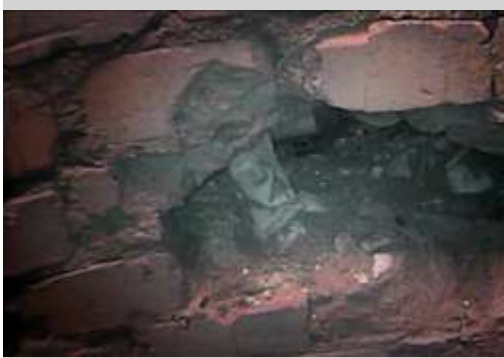
Defect

Barrel deterioration and infiltration.

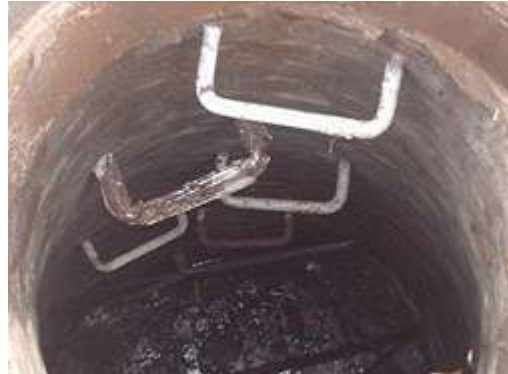
Defect

Frame leaks. Adjustment deterioration and infiltration. Barrel infiltration.

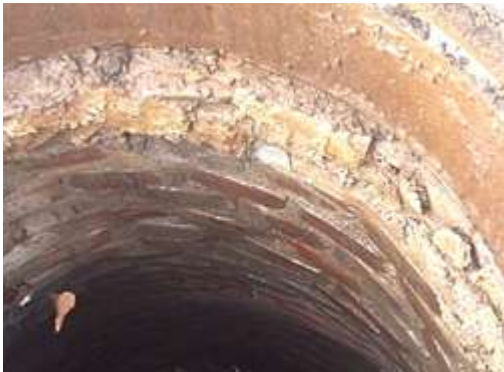
Defect

Frame leaks. Frame offset. Adjustment deterioration and infiltration.

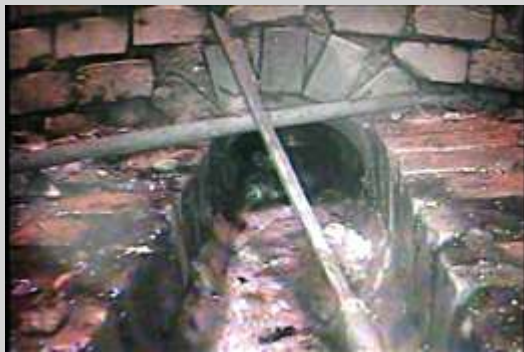
8 in. Circular Gravity Sewer Pipe Out @ 12 O'Clock

Barrel deterioration and infiltration.

Deposits: ☐ None ☒ Mud ☐ Sludge ☒ Debris ☒ Grease

Silt Depth: **1** (in.) Deposits Extent: **Light**

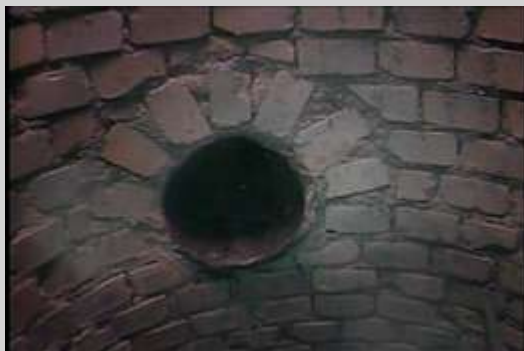
8 in. Circular Gravity Sewer Pipe In @ 6 O'Clock

Infiltration: **Evidence** Pipe Seal Cond: **Unknown**
